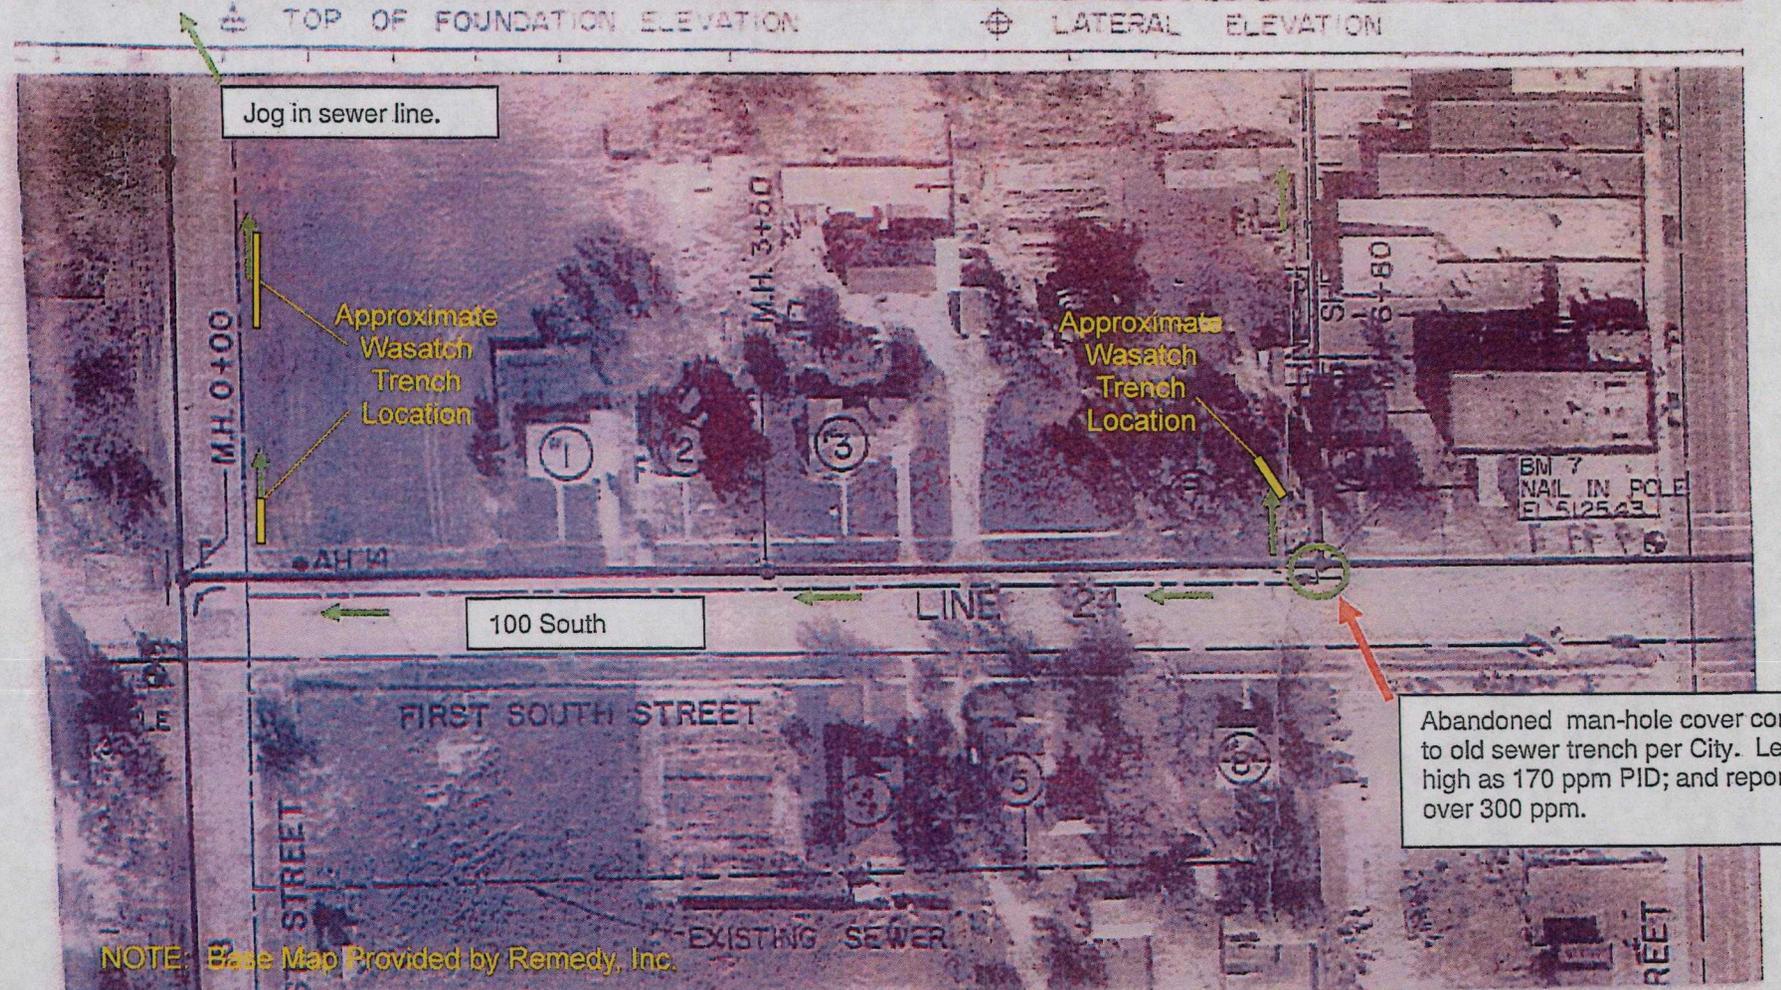
Abandoned man-hole cover connected to old sewer trench per City. Levels as high as 170 ppm PID; and reportedly over 300 ppm.

**OLD SEWER TRENCH:** Threatening locales at least from 89 W. Center Street south to 100 South; east along 100 South to alley way at approximately 28 West; and thence north along alley way behind theater terminating at old bathroom plumbing in Gunnison Valley Bank basement. Impromptu pneumatic pump test conducted by Remedy and Wasatch while testing vapors at manhole cover proved pneumatic connection between SVE Unit, plume and sewer trench (11/19/2007).
